OAEVT DISPATCH

Ohio Association of Emergency Vehicle Technicians

OAEVT JULY 2022 ISSUE 1 VOLUME 2

Minimizing Over-the-Road Accidents

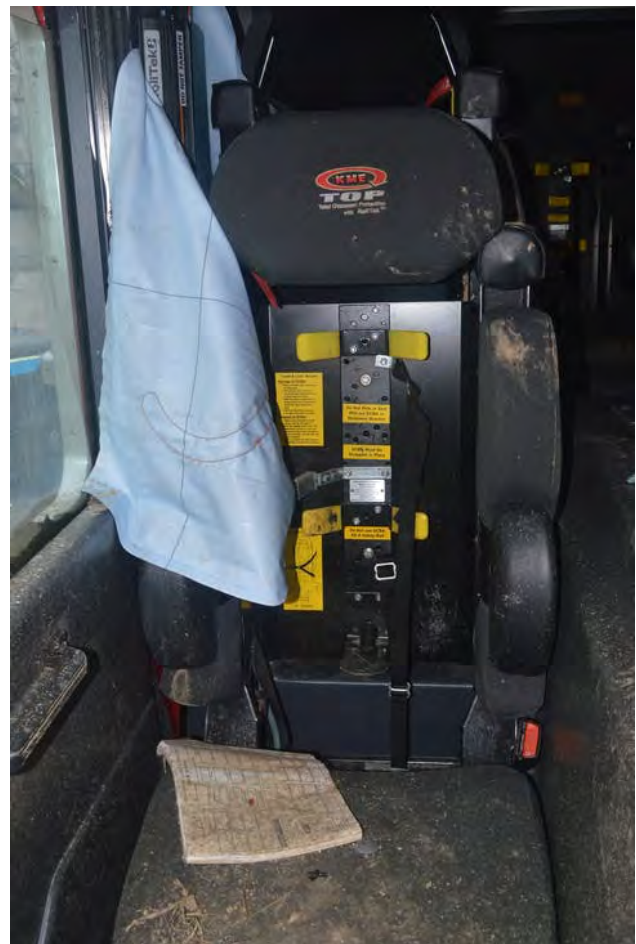
A side curtain air bag in a fire apparatus deployed after a quarter rollover. None of the six seat-belted firefighters who were on board were injured.

When an imminent rollover of the apparatus is sensed, advanced safety systems activate. This safety system activation includes buckle pretensioners and side air bags. When deployed, the system protects firefighters' head and neck.

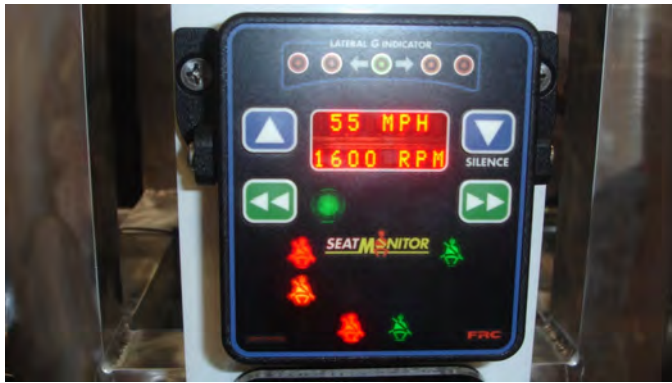
A digital display on a vehicle data recorder (VDR) gives the operator and the officer a variety of safety information about the apparatus and the onboard personnel.

In 2009, NFPA 1901 was revised to require the installation in fire apparatus of vehicle data recorders (VDRs), which also are known as the black box. High-end VDRs can capture vehicle speed, braking and auxiliary braking. Some have lateral G-force indicators to alert the driver via a series of lights on the dash of an impending rollover event. The VDR also can record time and date as to when a seat was occupied and whether and when a seat belt was engaged and buckled. Because weight sensors within the seats interface with the seat belt system, the seat belt must be buckled around the firefighter: no circumventing the operation of seat belt sensors by buckling the seat belt behind the firefighter, as is possible with other seat belt systems.

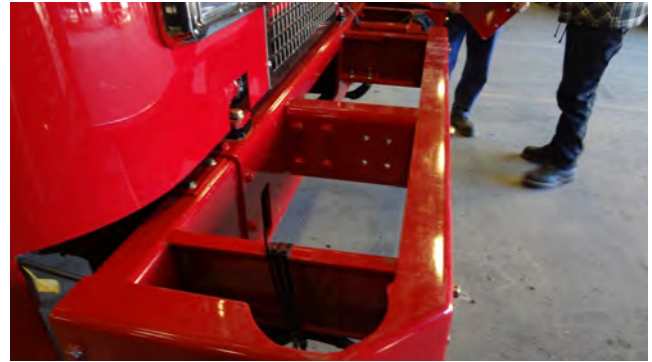
Steel reinforced front bumpers have become a popular option to protect the crew from cab intrusion.

FDNY further strengthened its apparatus specifications by requiring a steel reinforced front bumper to prevent intrusion into the cab during apparatus accidents to protect personnel in the front of the cab.

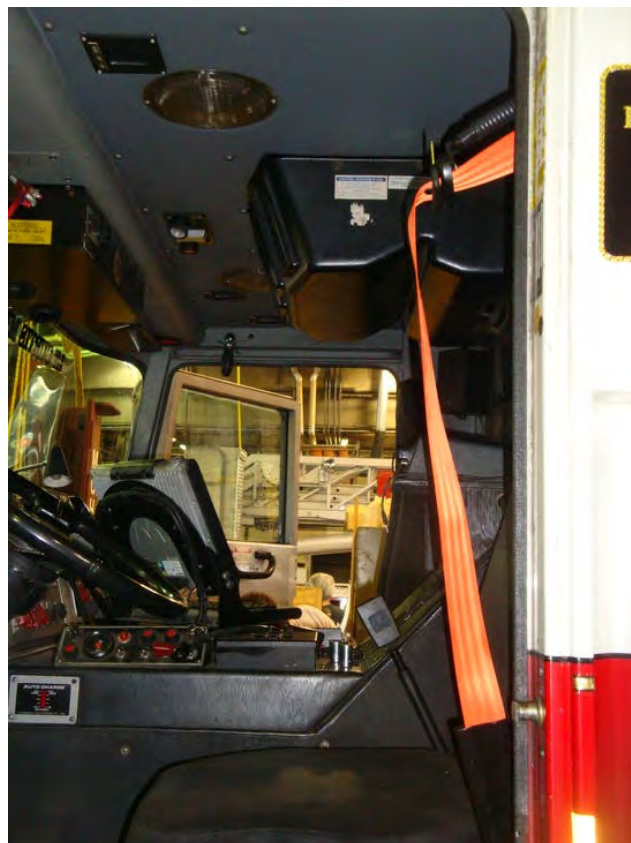
The increased length of the stalk of the ReadyReach seat belt helps to accommodate the increased size of a firefighter in bunker gear.

Over an 18-month period, IMMI produced eight different prototype seat belts. Each of the prototypes were tried in a variety of FDNY apparatus. The result: the ReadyReach seat belt, which was named for the ease with which it's donned and doffed. An extender arm that's located adjacent to the top of the seat pushes the male end of the seat belt beyond the seat and the firefighter; the increased length of the seat belt stalk helps to accommodate the increased size of a firefighter who is in bunker gear. The seat belt can be donned in four seconds. Seat belt usage in FDNY increased dramatically.

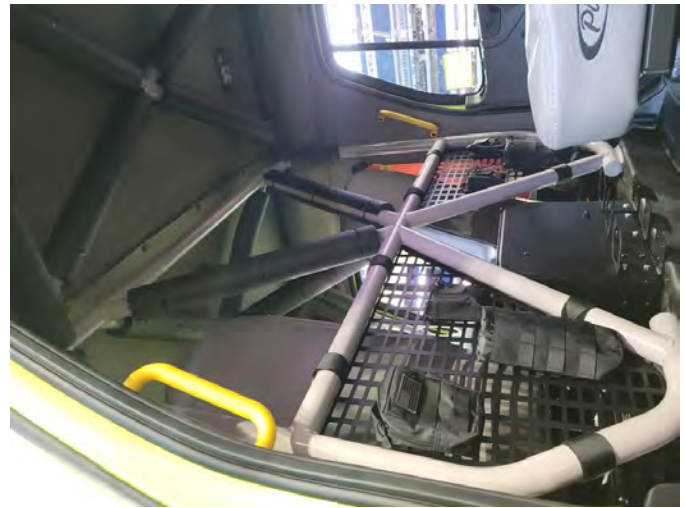
The Bureau of Land Management (BLM) provides fire protection on federal lands in the wildland urban interface. The BLM recently bid a specification that requires the manufacturer that upfits the commercial chassis of an apparatus to build a roll cage within the cab.

The [Bureau of Land Management](#) (BLM), which is an arm of the [U.S. Department of the Interior](#), provides fire protection on federal lands in the wildland urban interface. The BLM recently bid a specification that requires the manufacturer that upfits the commercial chassis to build a roll cage within the cab of the commercial chassis. It certainly is hoped that the roll cage that's upfitted in the commercial chassis for the BLM becomes the new normal for commercial cabs and will be
